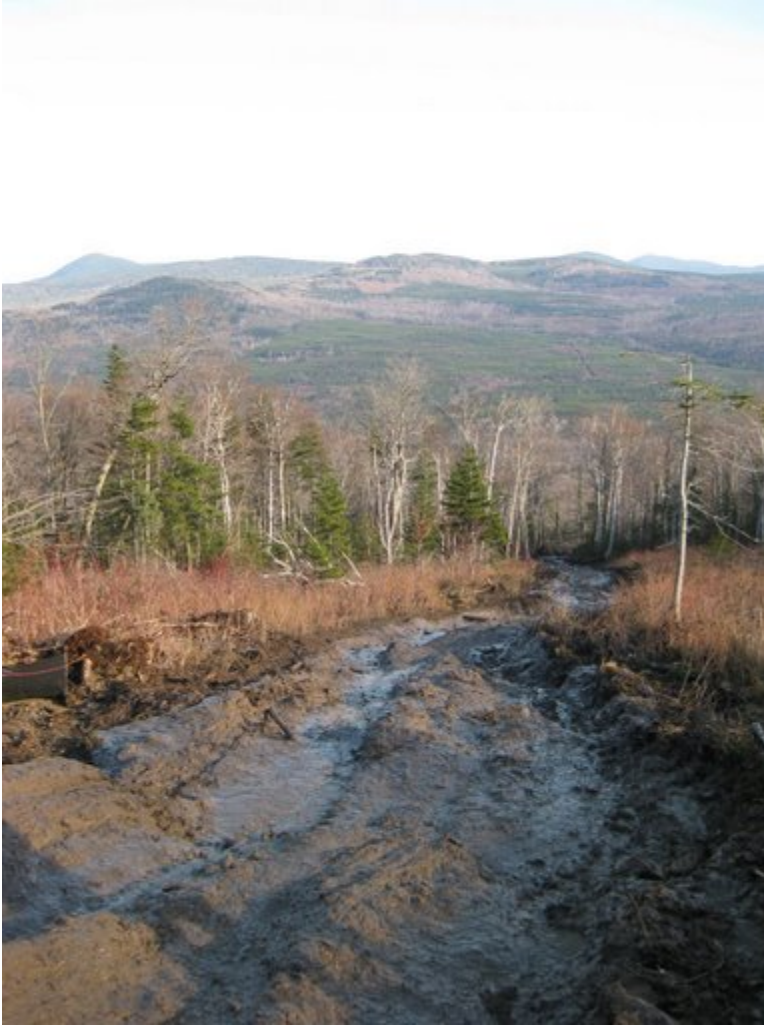
Heavy mucked wheel ruts along the skidder access road overlook A18 site preparation in the background.

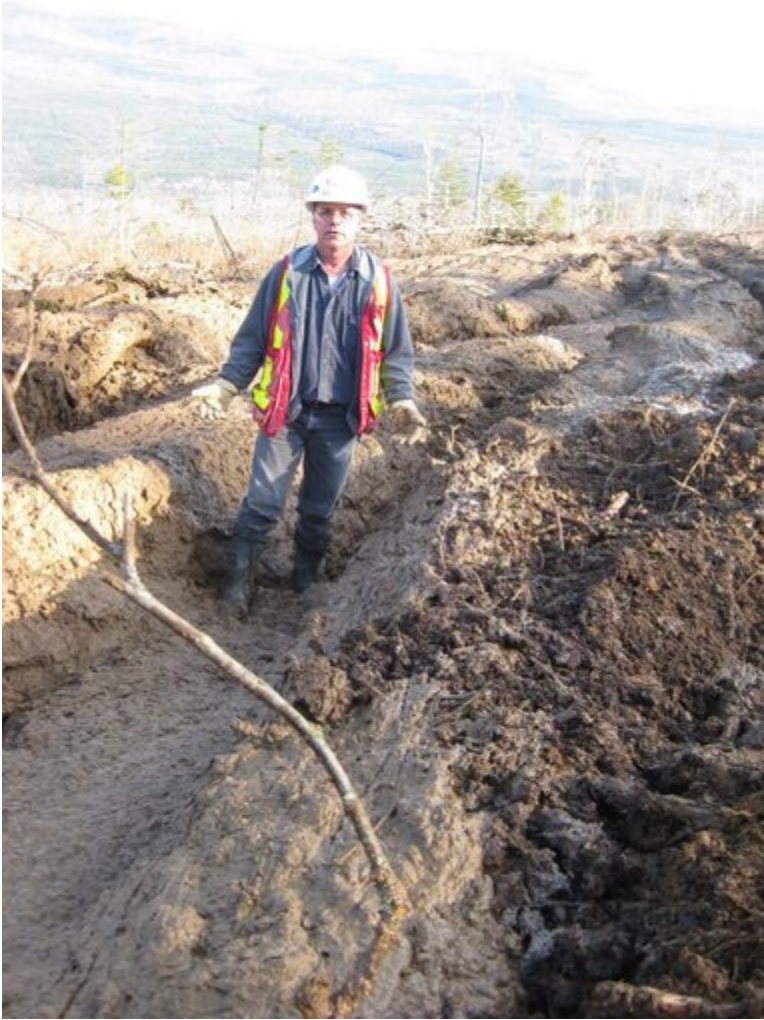
Standing in a thigh high wheel rut typical along the top portion of the access road. It was near this area that a skidder with 4 chained tires became stuck (bottomed out the carriage frame) and had to be pulled out of skidder road by other skidder and cable.

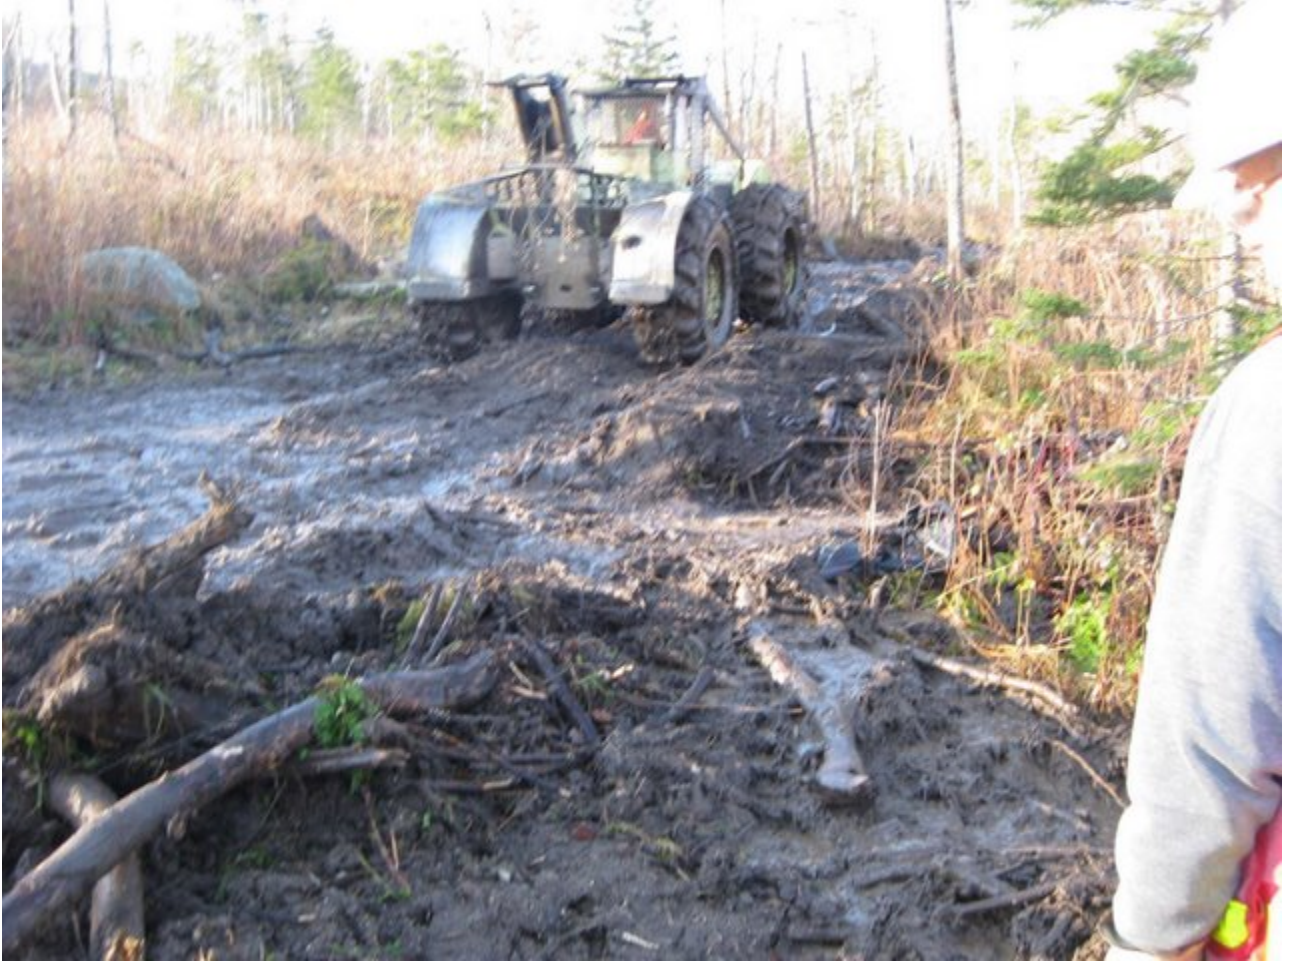
Skidder in mud: **A short 6' section of silt fence could not hold back the volume of sedimentation that ran down the wheel ruts.**

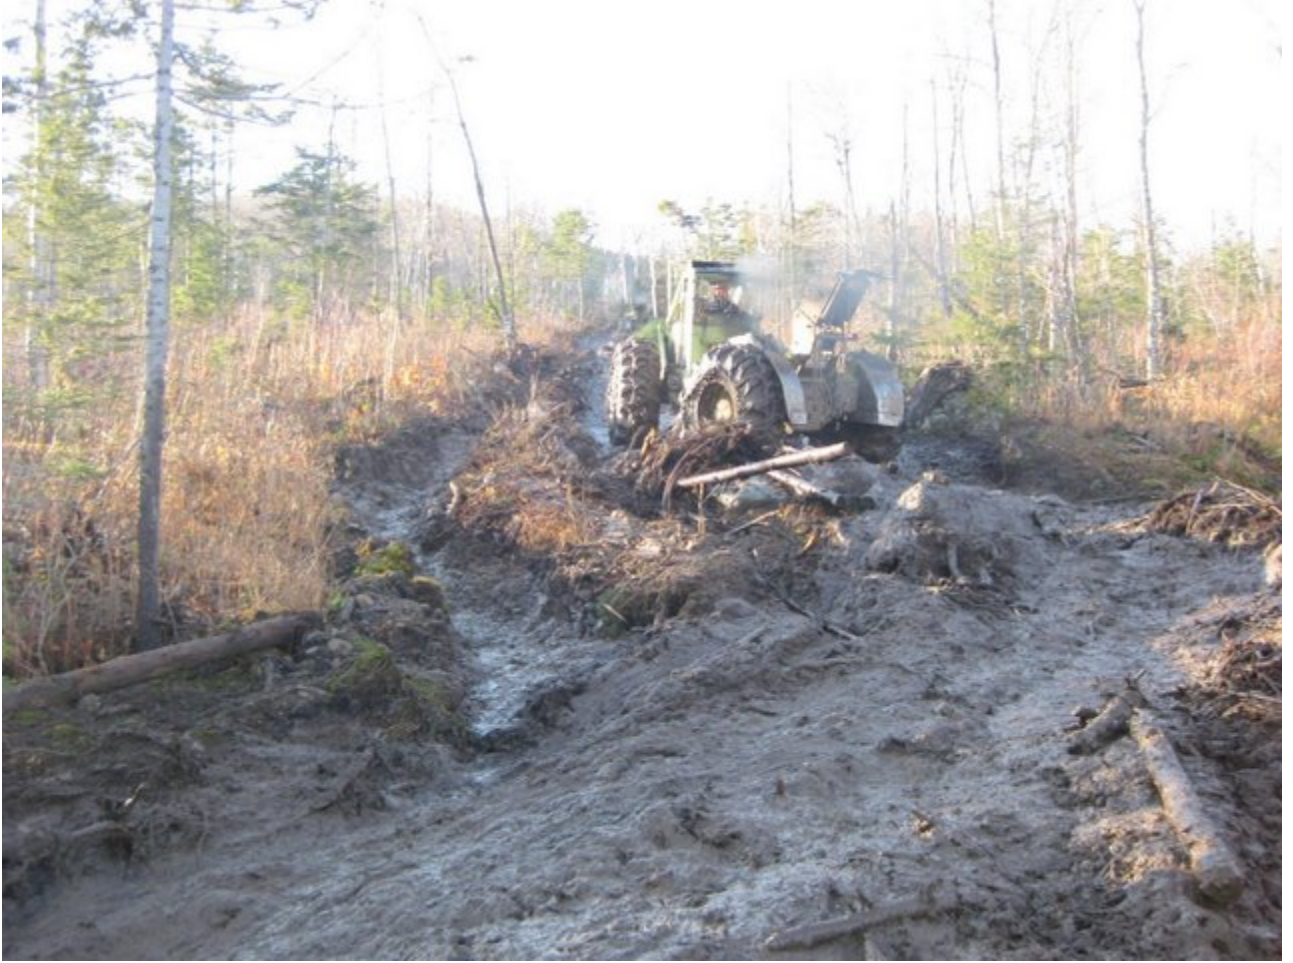
Mud flows.....5 skidders were to work this access road today.

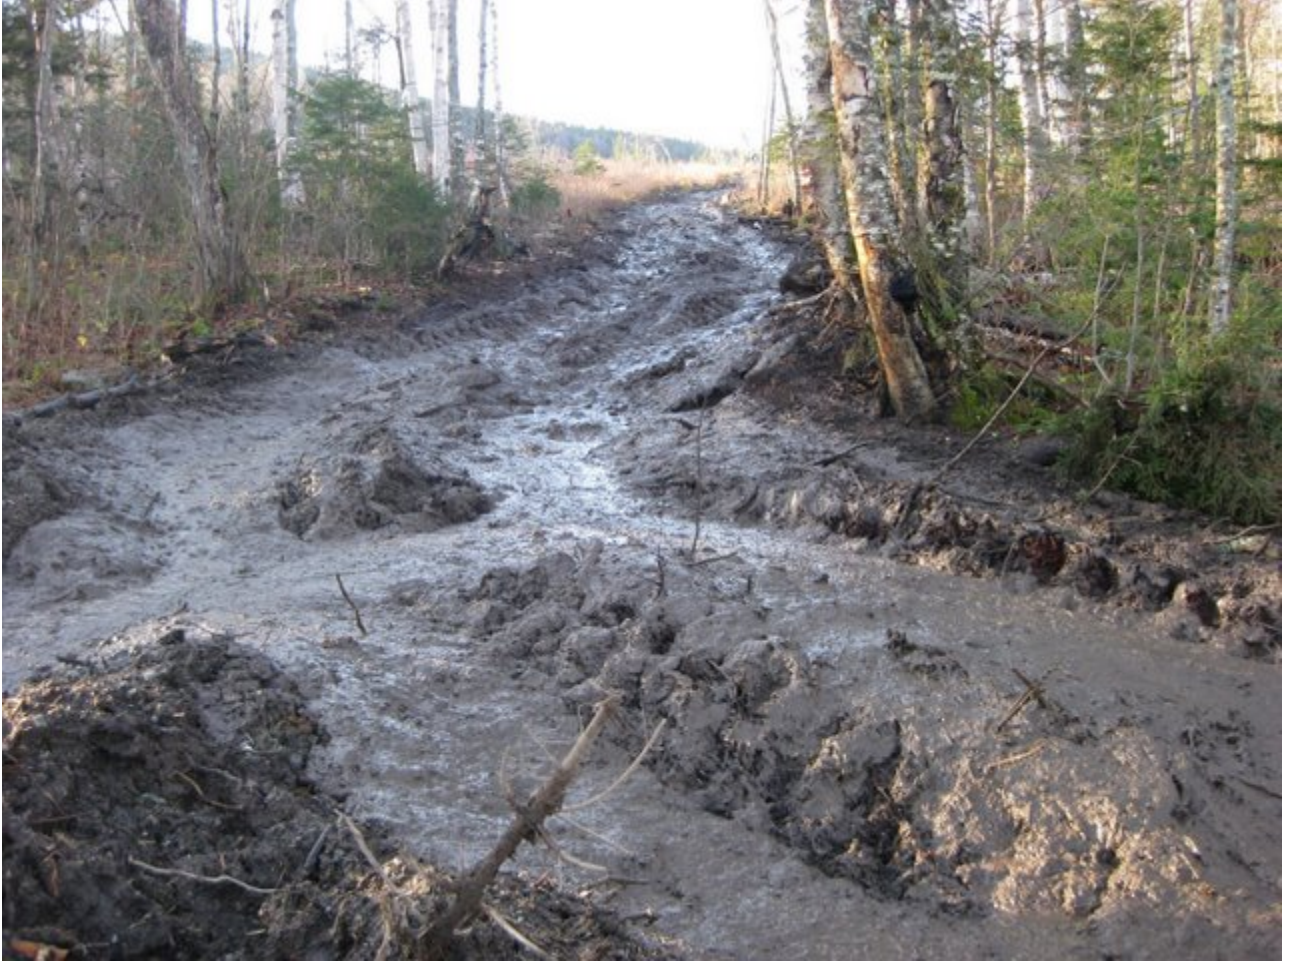
The mud flows are so heavy here it has to pick where it wants to go.....into the breached silt fence or continue down the wheel ruts.
